SUBJECT: LA 6-200-C Model

DATE: December 30, 1935

TO ALL OFFICES:

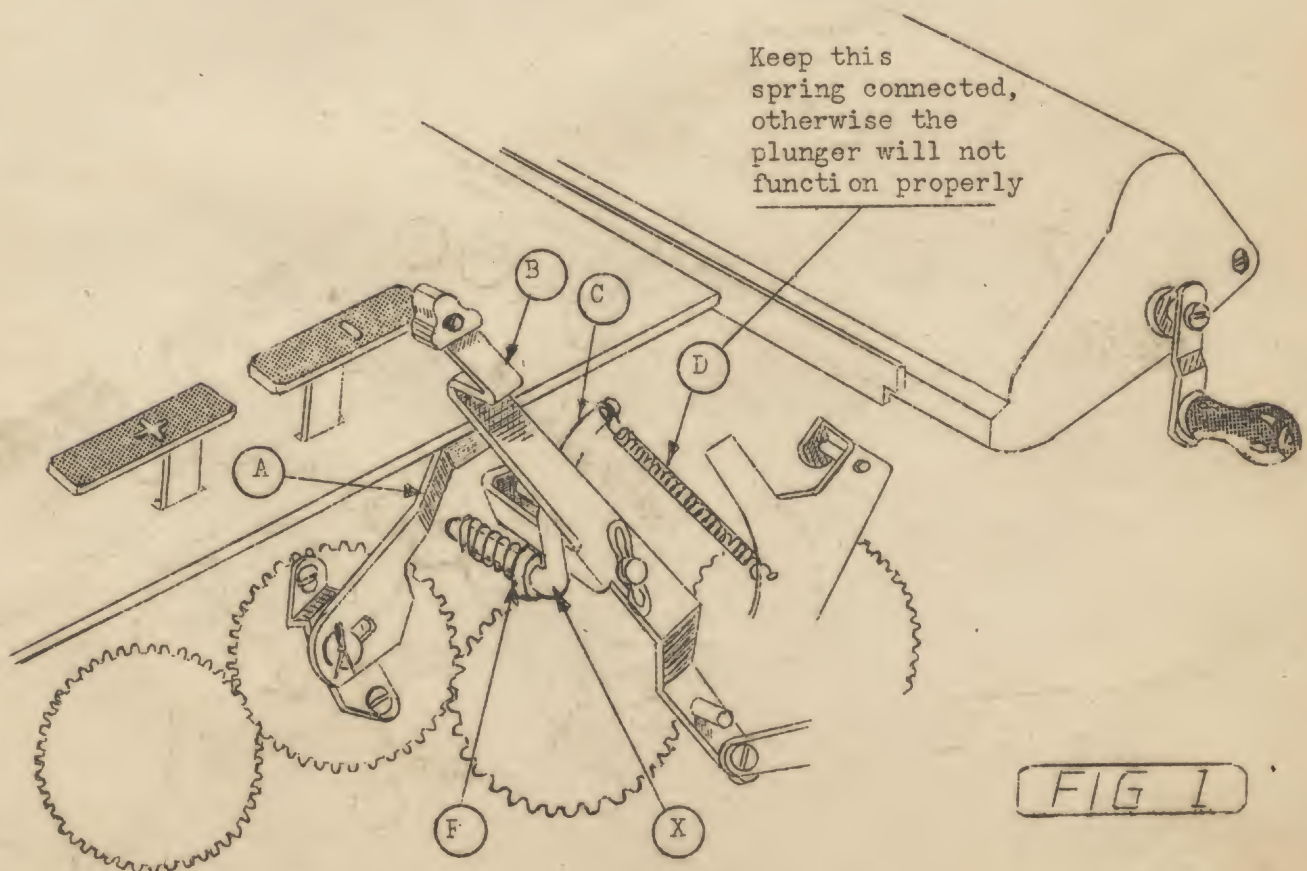
- 1 Stock has been removed from the 49070 counting finger (A) to avoid interference with the movement of the 47900 plunger rod. Figure 1.
- 2 If, after the trip lever (K) and the 41-776 guide bracket (Z) have been adjusted the plunger rod (J) should strike the inner side of the 41-777xl trip lever (K) instead of positioning over it as shown in Figure 3, remove stock from the top of lug (L) to suit.

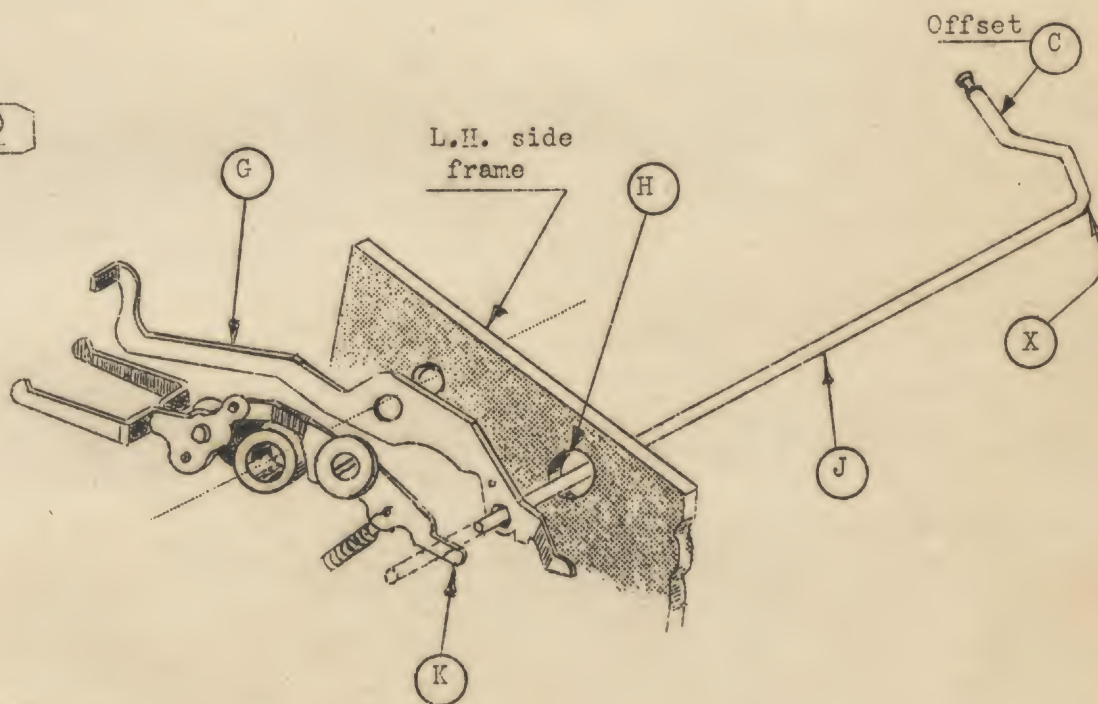
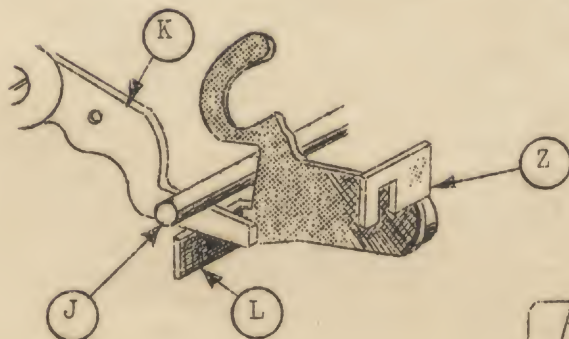
FIG. 2

- 3 If the plunger rod (J) does not withdraw from engagement with the trip lever (K) when the multiplication lever is positioned toward the rear of the machine, bend the offset (C) of the plunger rod inward at (X).

- 4 If the plunger rod (J) does not engage the trip lever (K) when the multiplication lever is in neutral, bend the offset (C) of the plunger (J) outward at (X).

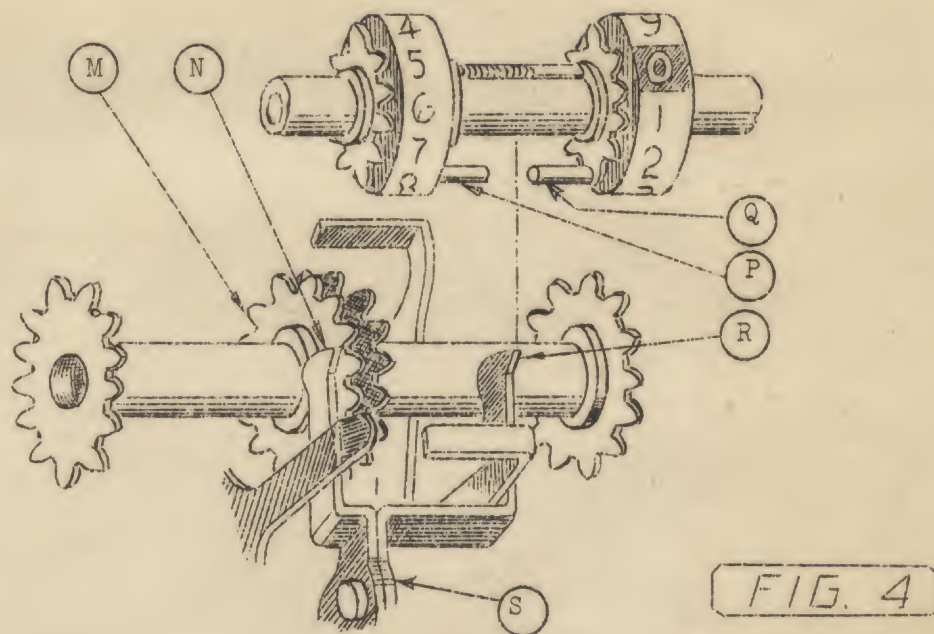
FIG. 3

6. The outer prong (N) of the trip lever (S) should be adjusted as close as possible to the extra carry gear (M) without causing it to bind.
7. Care should be taken that the clearing pins (P) and the 41-527 carrying pins (Q) do not interfere with lug (R).
